Site Safety Survey

Temecula Campus

January 26, 2018

Completed by:
Scott Boggess, CSP, CIE, SH&E Professional

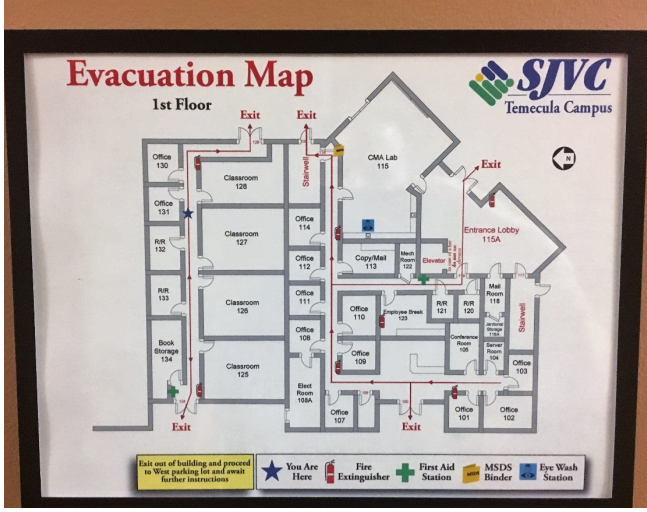
| Observation | Photo |
|---|--|
| <p>Throughout the facility</p> <ul style="list-style-type: none"> • There was consistently good emergency signage – of exits, fire extinguishers, evacuations routes, first aid kits, MSDS (SDS) binders, and PPE requirements. • Keep up the good work, stay vigilant, and be sure to update maps and signs as conditions change. | |

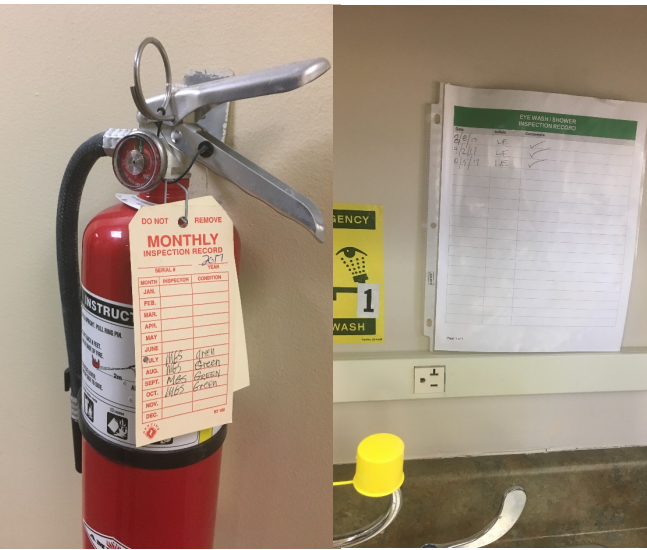
| Observation | Photo |
|---|--|
| <p>Throughout the facility</p> <ul style="list-style-type: none"> • Fire extinguishers, eye wash stations, first aid kits, and MSDS binders were inspected, and the inspections were documented on tags placed on or near the item. • Nicely done. Monthly inspections are required for fire extinguishers and eye wash stations. | |

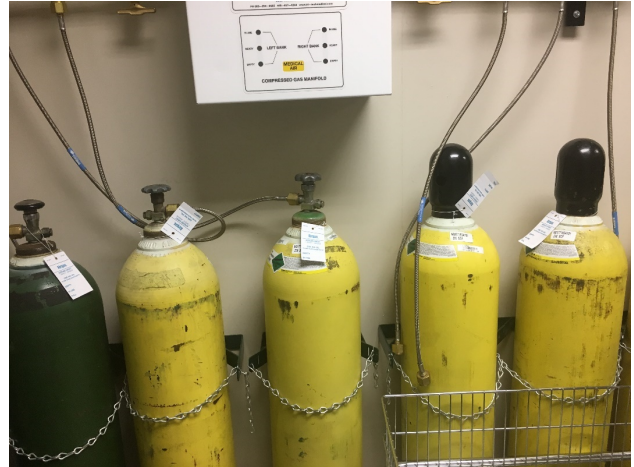
Medical gases and HVAC

- Compressed gas cylinders (oxygen and medical air) were all observed to be properly secured. Cylinders not in use were capped.
- Nice job. Cylinders in the HVAC area were secured as well.

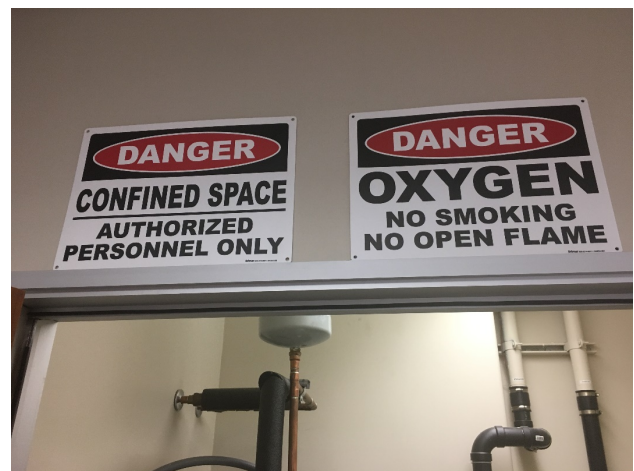
Dental Lab Equipment Room

- **Issue:** A confined space sign was placed above the door, yet no confined space was noted.
- **Solution:** Remove the sign if no confined space is identified.

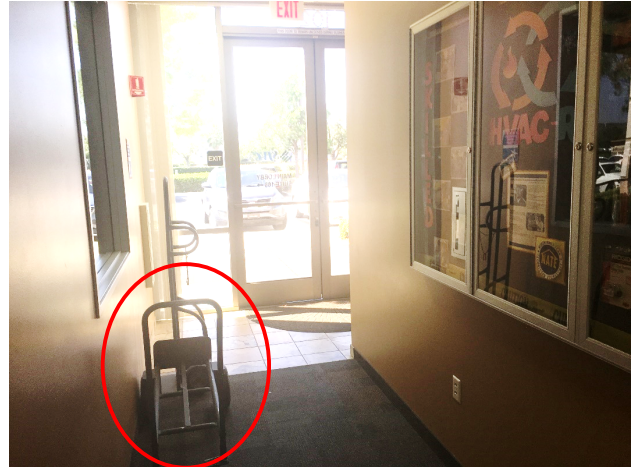
Exit Corridor

- **Issue:** A hand truck was parked in the hallway partially blocking an emergency exit corridor.
- **Solution:** This was very likely a temporary condition, but it's a good reminder to keep exit pathways clear at all times.

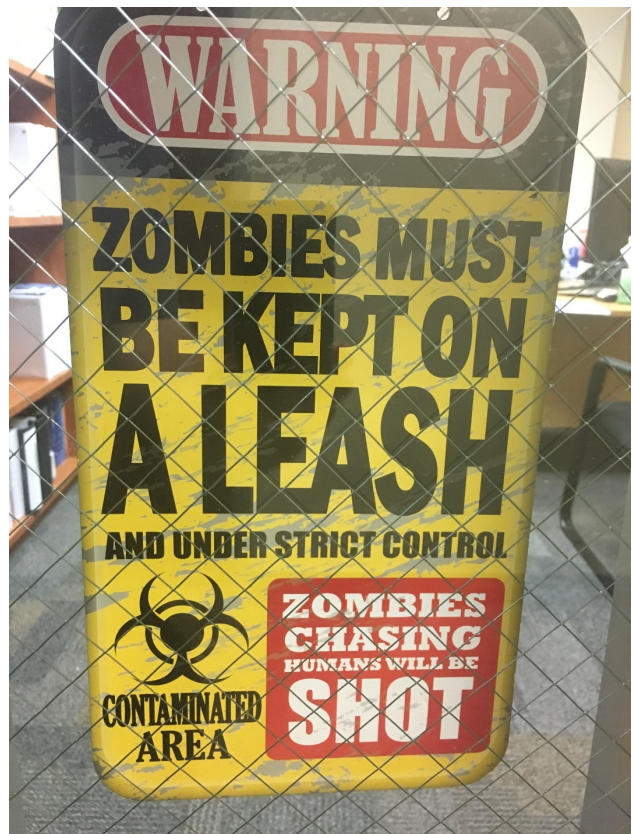
Throughout the Facility

- A sense of humor, high engagement in safety, and people who care about the work environment were all demonstrated by the employees who hosted me – Robyn, James, and Lawrence.
- Robyn is highly involved in safety and sets the tone from the top.

The Temecula campus showed very well overall. The facility is newer, is well-maintained, and housekeeping was good throughout. Robyn was clearly knowledgeable and involved in safety. She has a solid team of James and Lawrence supporting her. As mentioned next to the “Zombie” photo above, this is no accident. It takes leadership and a dedicated approach to achieve and maintain a safe workplace.
